LBK-ADDs Schematic

DDQ12/LA1901 Schematic with Capture CIS and Function field
uFCPGA Banias
06-24-2003
REV: 1.0

DELL CONFIDENTIAL/PROPRIETARY		
Compal Electronics, Inc.		
Title		
Cover Sheet		
Size	Document Number	Rev
	DDQ12/11/01 with LA-1901	1.0
Date:	Thursday, July 03, 2003	Sheet 1 of 58

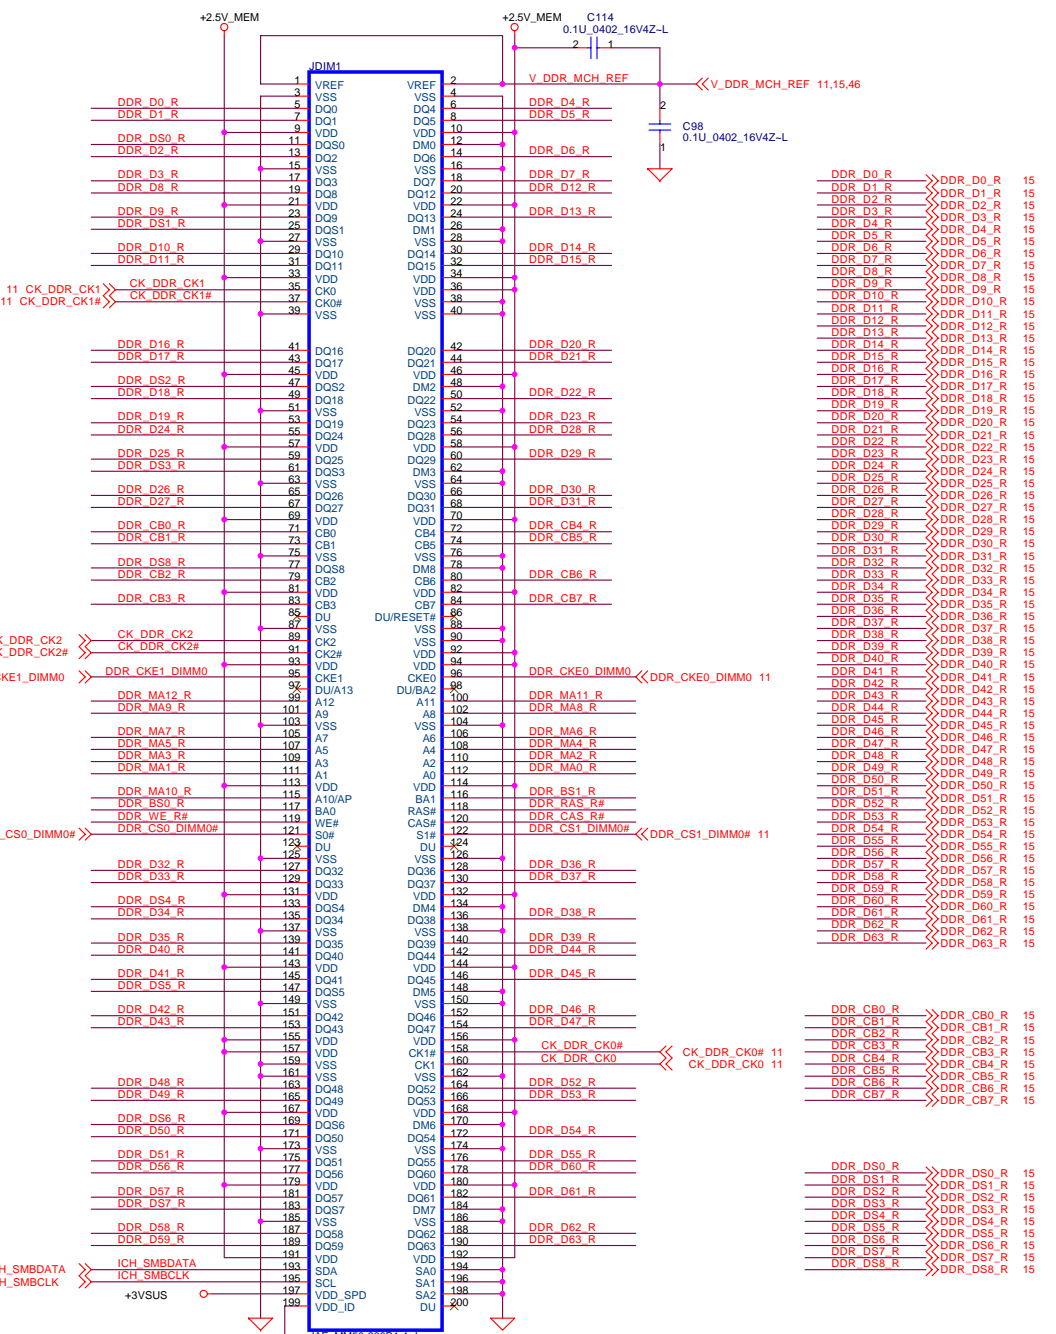
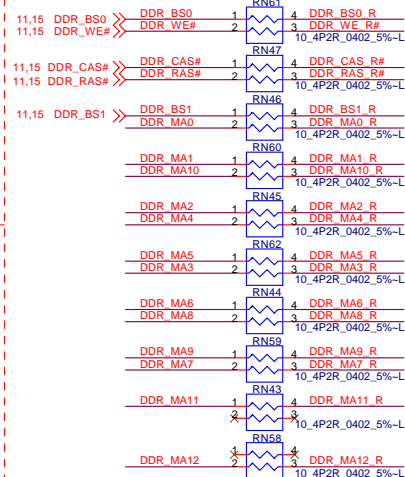
Layout Note:
Place these resistor
closely DIMM0,all
trace length<750 mil

Layout Note:
Place these resistor
closely DIMM0,all
trace length
Max=1.3"

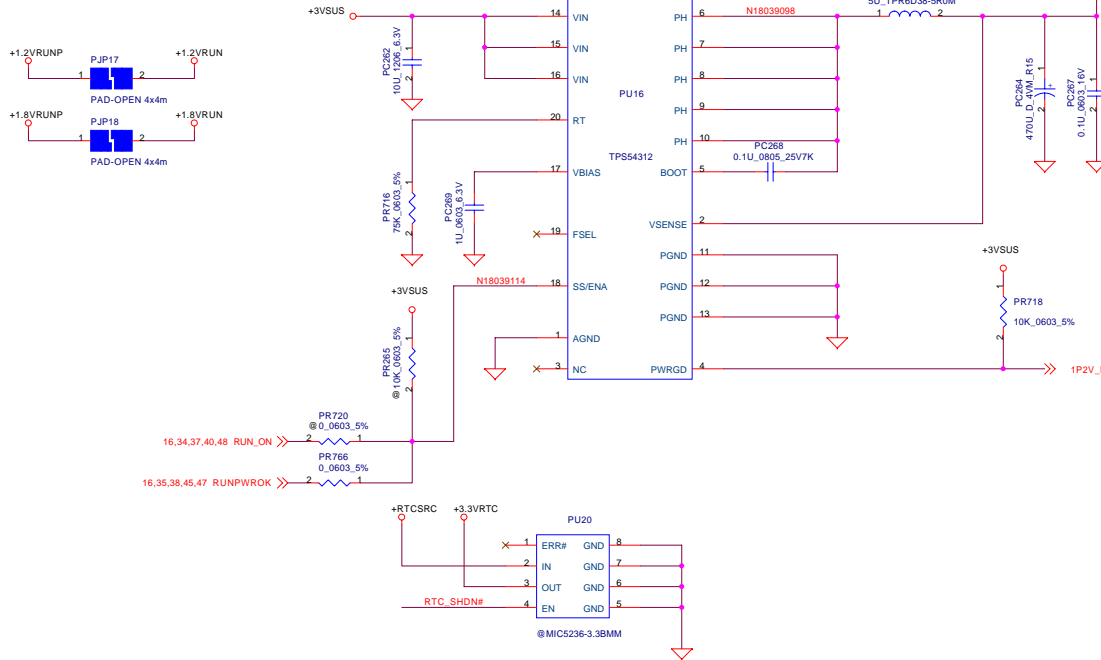
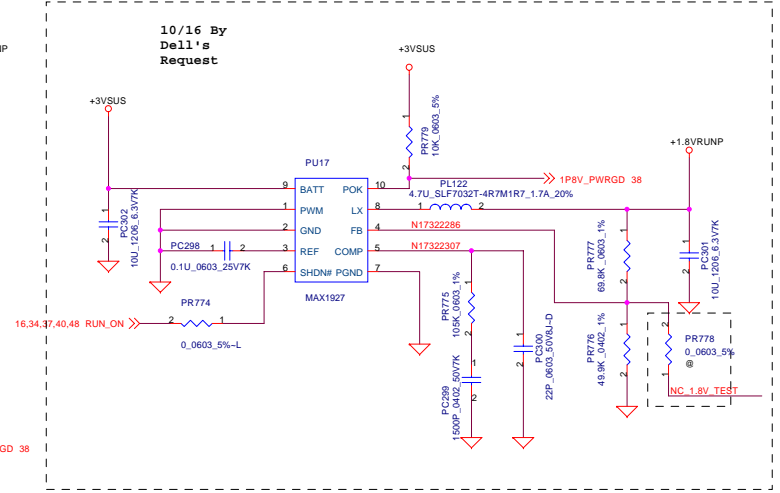
+1.2VRUN/+1.8VRUN SOURCE

Allows SUS planes to power ALW planes when possible

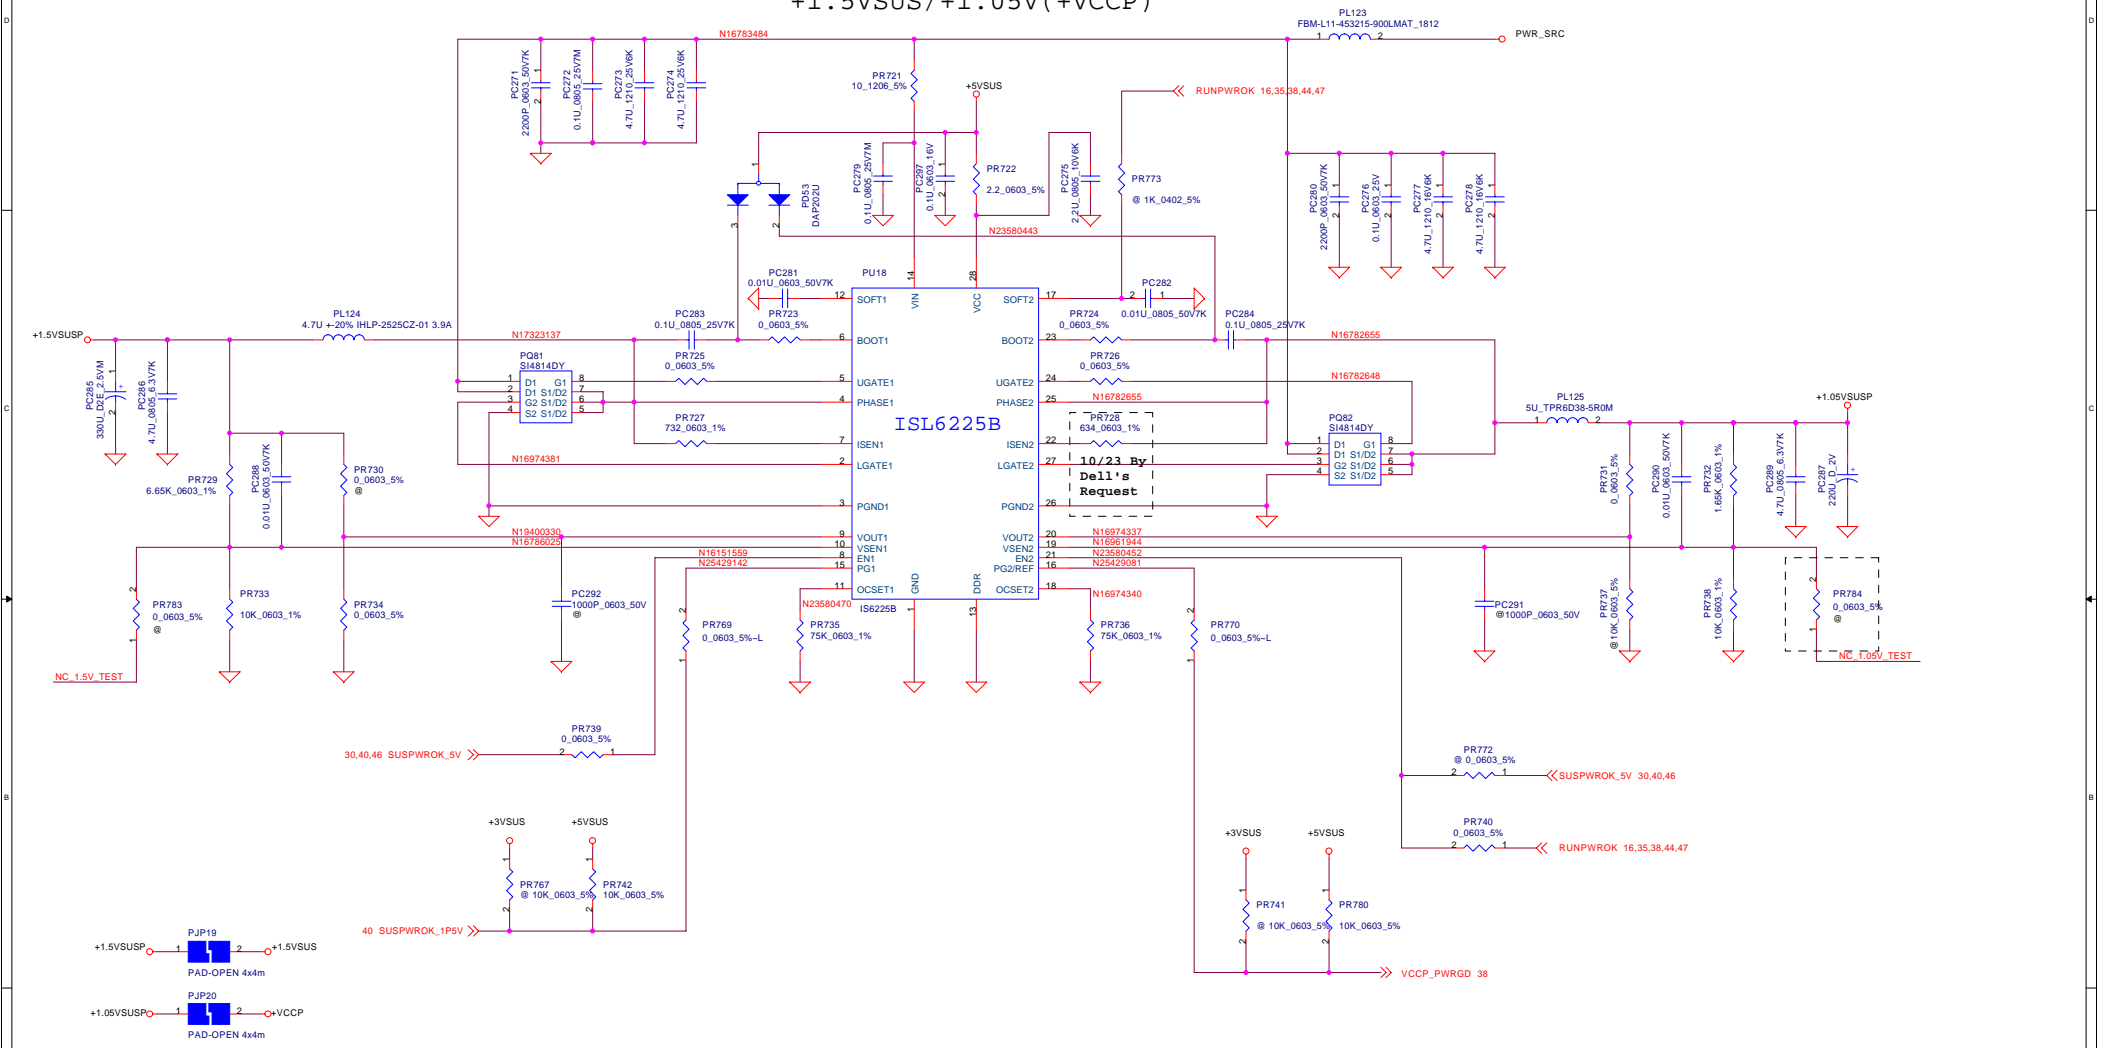
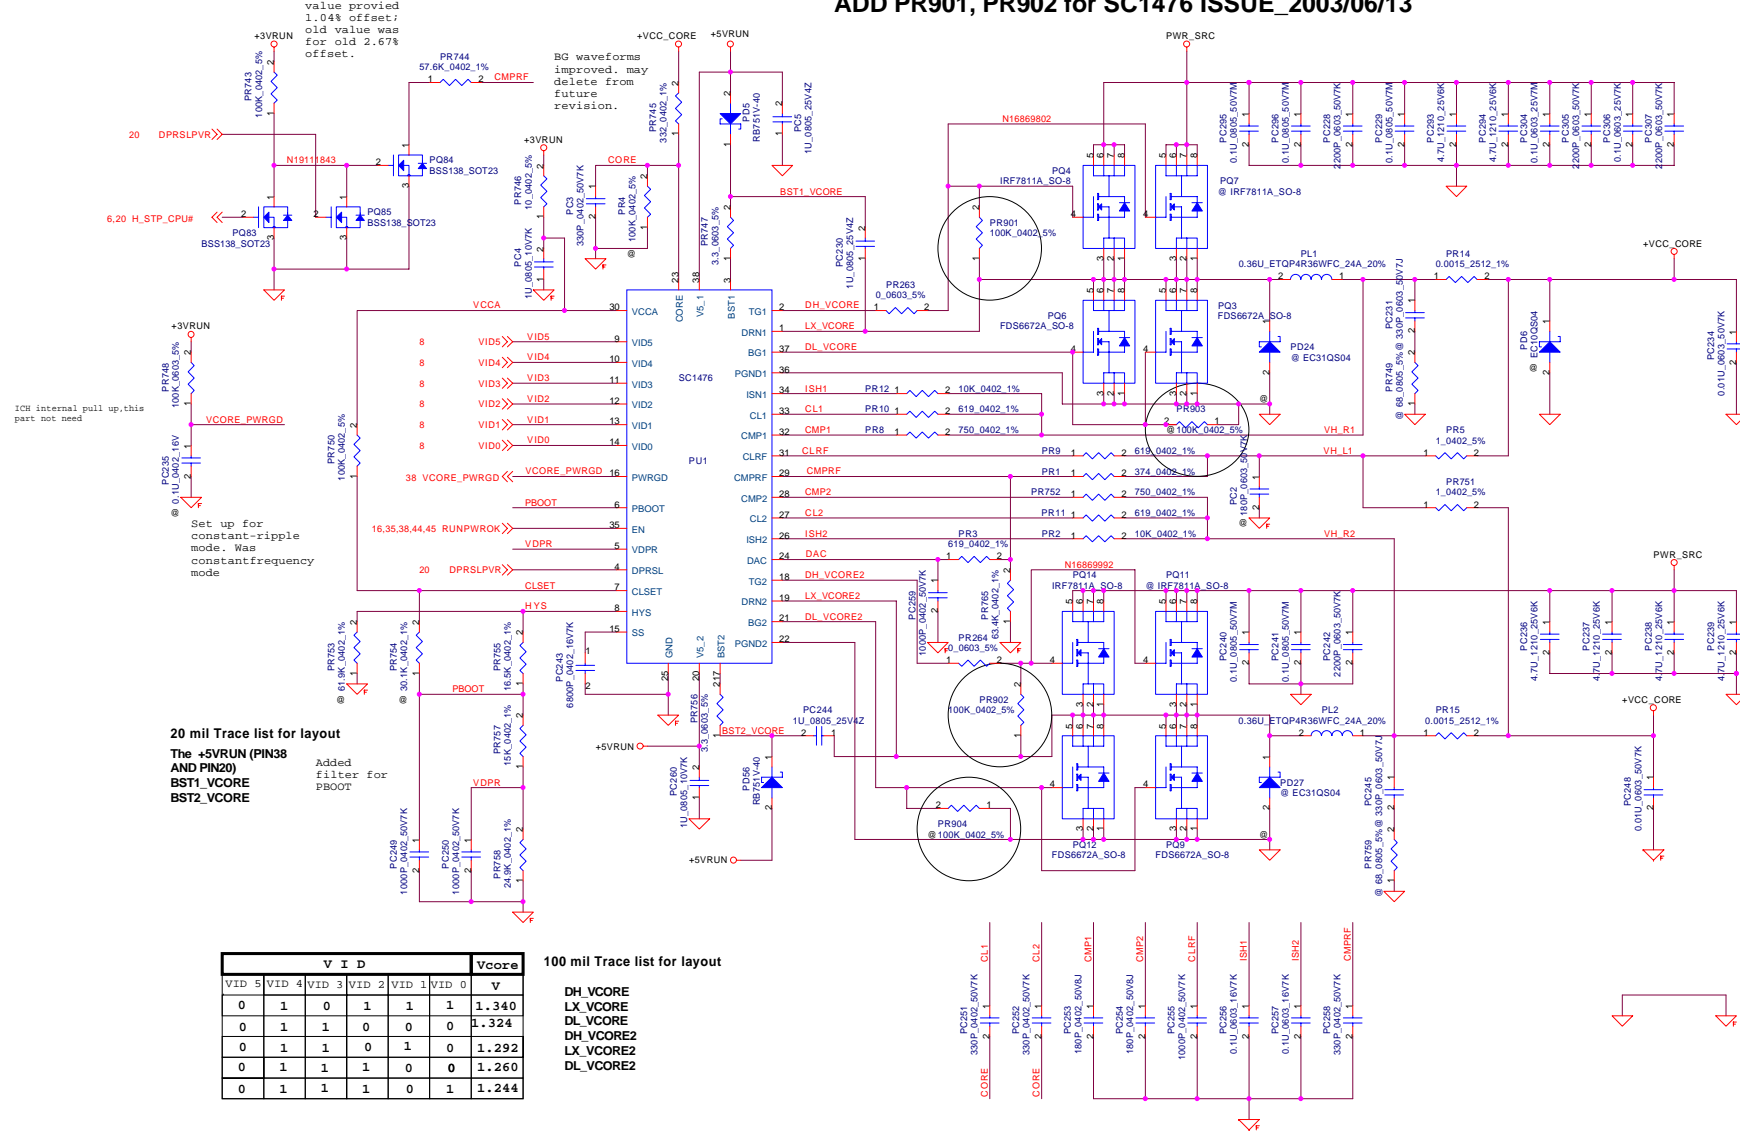
Title
SCHEM,PLN,MN,KAPALUA II VCC_CORE
Size Document Number
DDQ12/11/01 with LA-1901
Date: Thursday, July 03, 2003 Sheet 47 of 58

ADD PR901, PR902 for SC1476 ISSUE_2003/06/13

35	43	Battery Conn.	03/05/2003	Dell	To Use Common Part as Bondi (Change PN to DC04001440L)	JSBAT	A00
36	49	Chagrger	03/05/2003	Compal	To Reduce RTC Bridge Battery Leakage Current (Changed Power Plane from +RTC_PWR to +5VALW)	PU13. PC216, PR637, PC217, Depop PR641	A01
37	42	Power DC-IN	04/07/2003	Dell	Reserve zero ohm bypass resistor for Rbatt fuse	Adding PR850(@)	X00
38	42	Power DC-IN	04/07/2003	Dell	Fuse PFS2 Removed and Diode PD3 Shorted. The RBAT Blow Up (200 deg F). POP the Fuse instead of the 0hom resister.	Pop PFS2 Depop PR850	X00
39	45	1.5V / 1.05V	04/23/2003	Dell	Increased OCP for S3 Issue. (330Q to 732Q)	PR727	X00
40	47	Vcc_core	06/13/2003	Dell	CPU_core PWM SC1476 IC issue	Adding PR901, PR902 to 100K, PR903(@) PR904(@)	A00

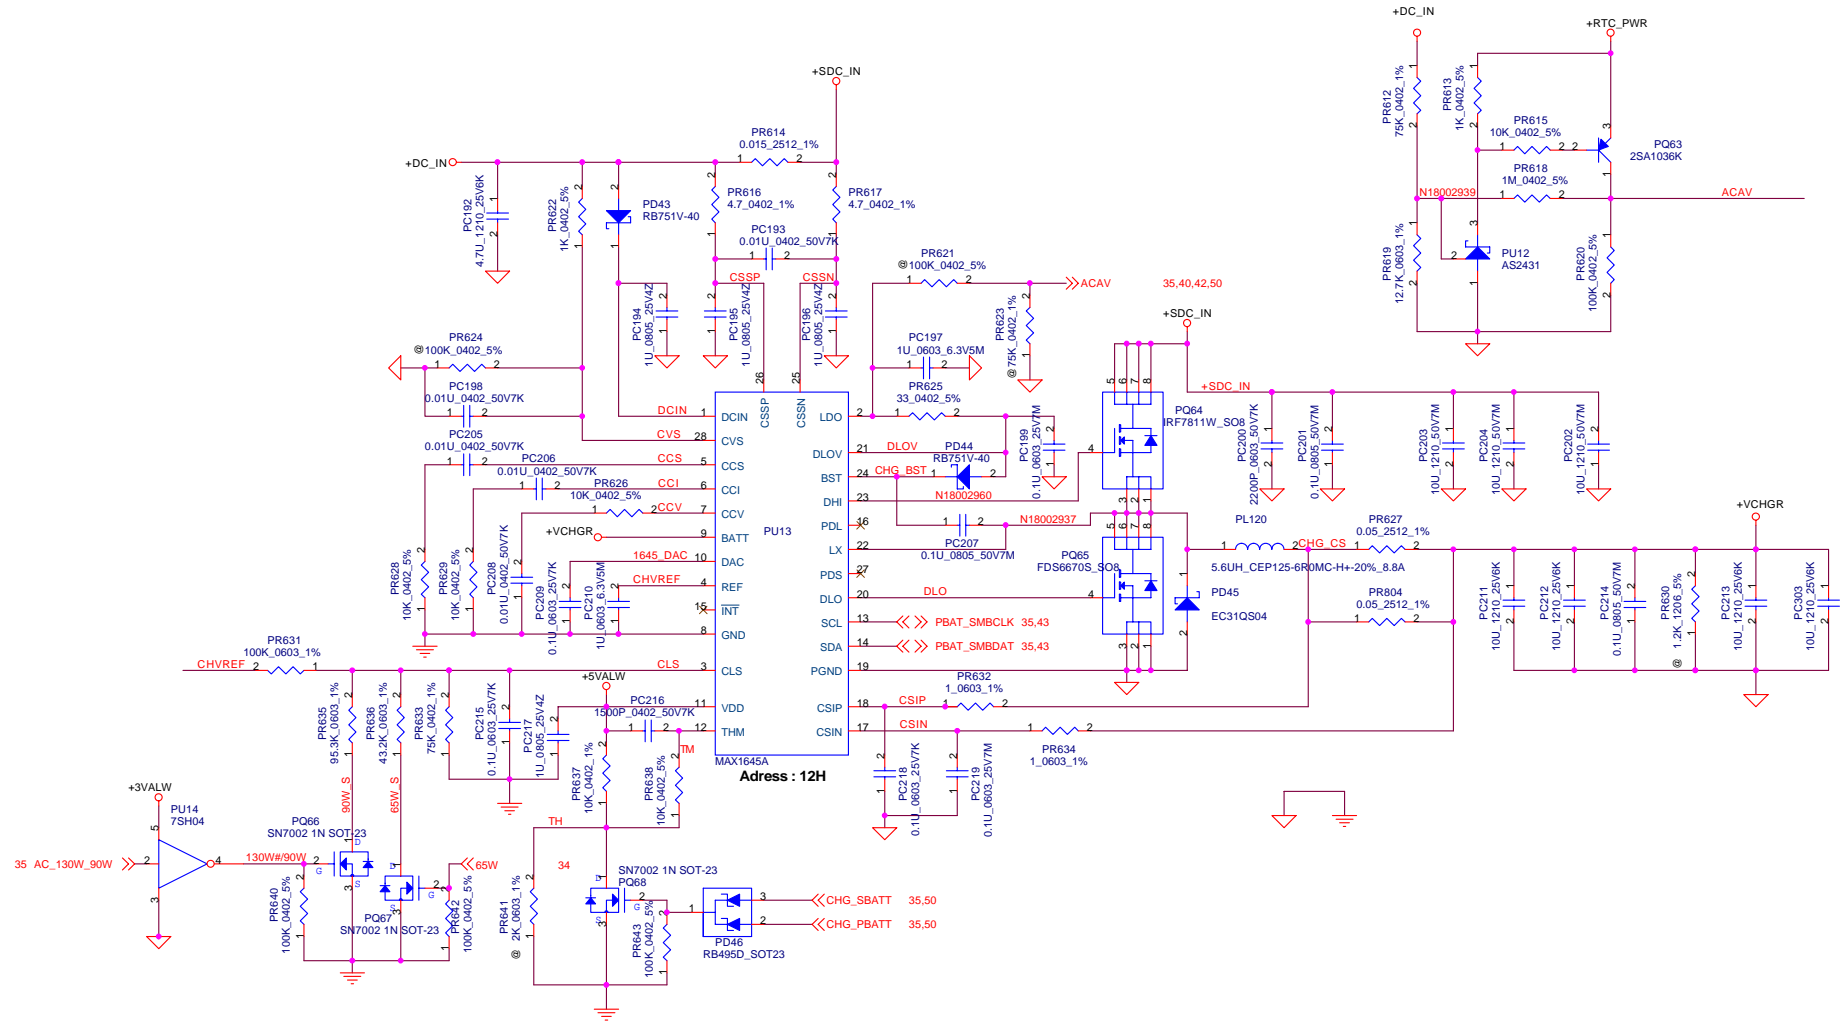
65W (2.93A)	90W (4.0A)	130W (5.85A)
65W	H	L	L
AC_130W_90W	H	L	H
